**GROOF**  
Greenhouses to Reduce CO<sub>2</sub> on roofS

PART 1 : ACCESS  
TO THE ROOF  
AND REMOVING  
THE OLD ROOF  
COVERING

# INTRODUCTION

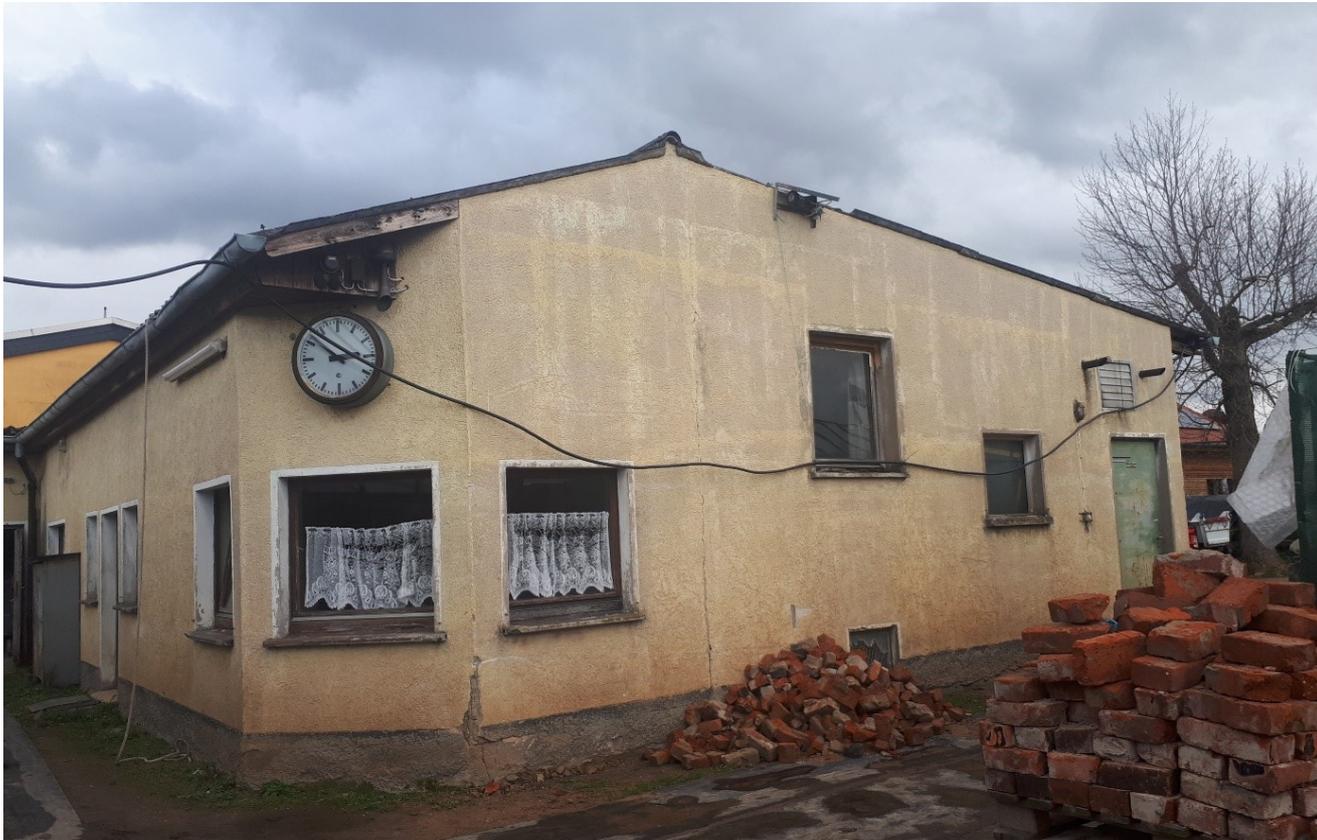
Figure 1 View on the support building from the north west corner

The building itself was constructed in the 60s and showed clear signs of a need for renovation (Figure 1). The previously established horticulture business on the site went bankrupt and was not able to maintain proper maintenance in the last years. After the end of the construction of the rooftop greenhouse the support building will undergo a full renewal to match the adjoined buildings

Despite the looks of the facade, the core of the building structure, especially the brickwork, was still in a predominantly good condition. Due to the large openings (doors and gates) throughout the building, large and heavy lintels were already in place serving a well laid out structure for the reinforcement for the greenhouse platform.

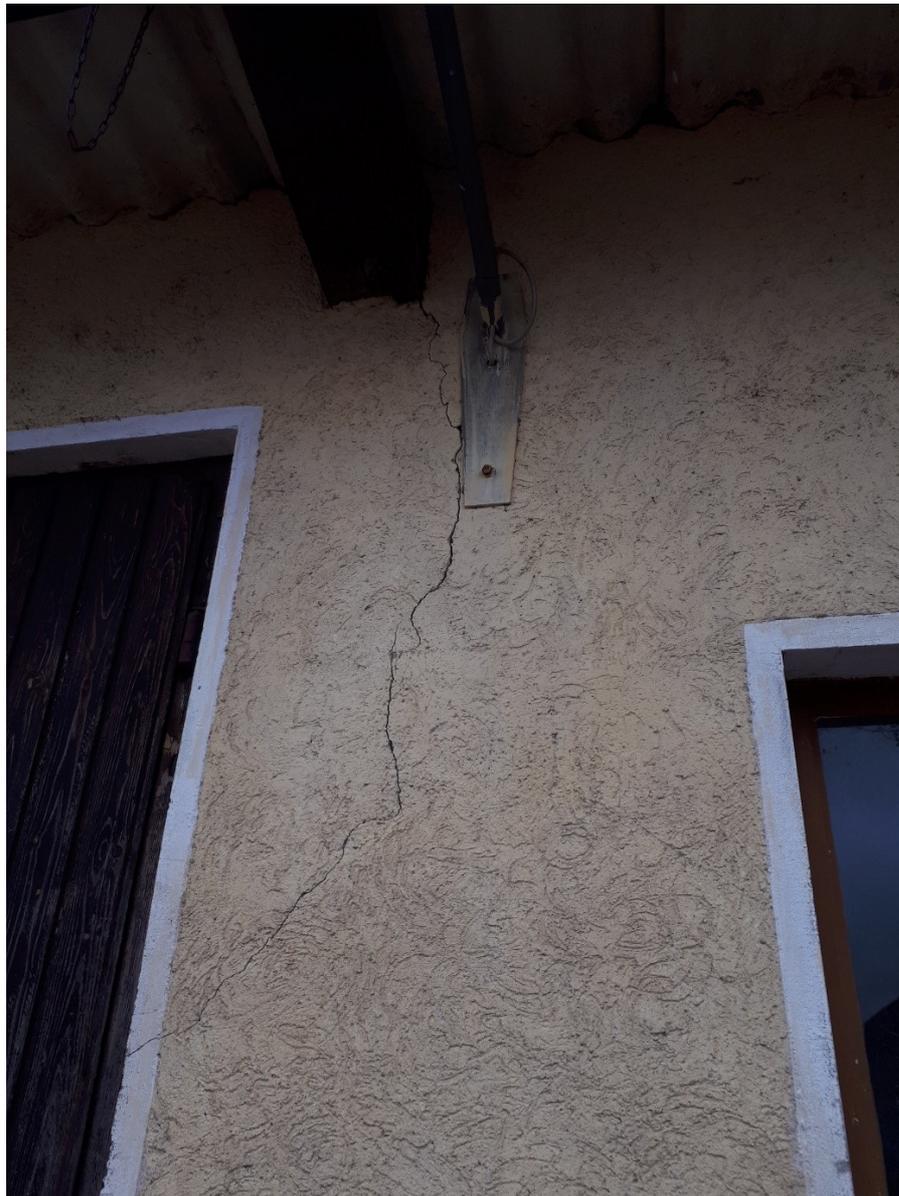
Figure 3 : Cracks in the wall due to the heavy load from the wooden beams

Due to the aforementioned asymmetry of the roof the load of the wooden beams on the walls had not been even which resulted in some minor damage to the walls underneath (Figure 3) resulting in cracks surrounding the bearing of the wooden beams in the brickwork.

Since the load of the greenhouse structure supporting platform is expected to be more balanced, any further problems to the brick structure could be mitigated.

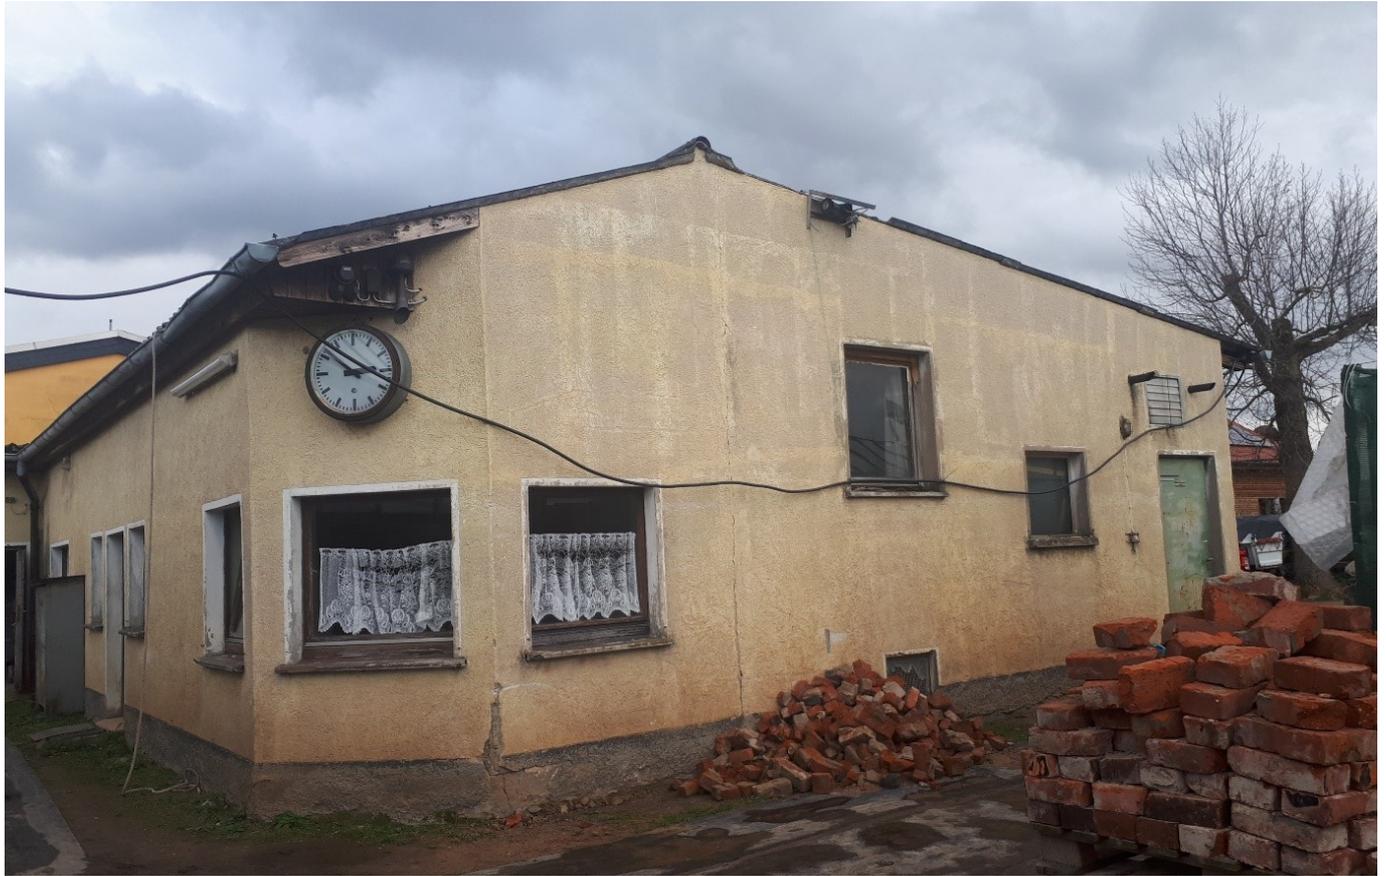
Figure 4 Deconstructed chimney

The gabled roof was asymmetric which meant for an uneven wall ending. The north side wall came out to be close to 55 cm lower than the south end. This needed to be evened out with the reinforcement structure. The old chimney was not in use anymore since the heating system was reorganized into a central heating for the whole site. From ground to the top it measured approximately 10 m and could not be integrated into the greenhouse structure. It was deconstructed carefully, stone by stone. The material was later repurposed as a ground cover in another greenhouse on site.

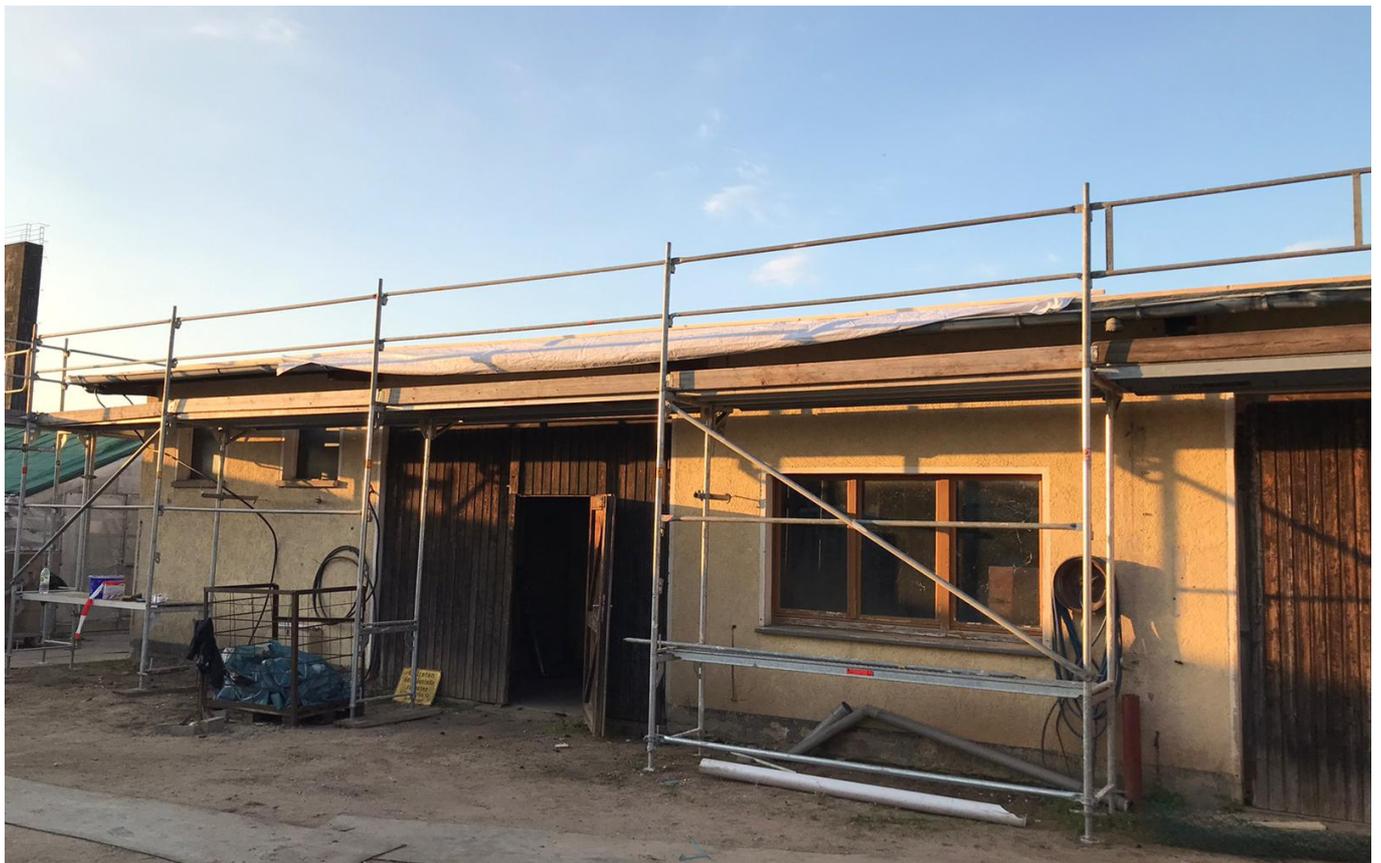
Figure 5 Support building surrounded by scyffolding, roof covering already removed

The removal of the wooden beams became complicated due to their heavy weight. As it can be seen in Figure 5 and 6 the space around the greenhouse is limited. No permanent crane could be installed to help with the removal of old material and subsequent installation of new construction materials. This work was executed by an experienced carpenter, who managed this work without heavy machinery.

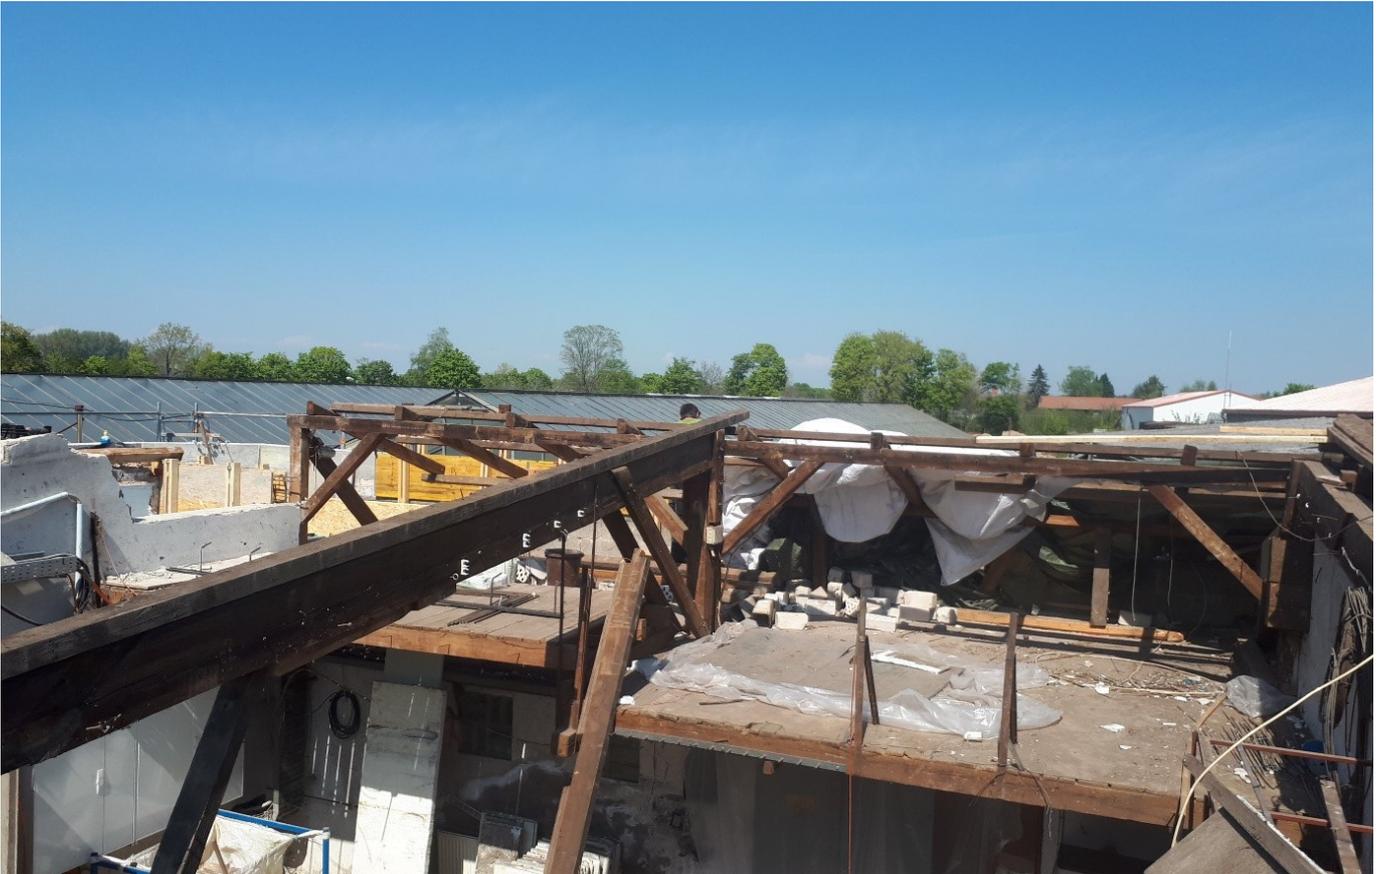
Figure 6 Underlying roof structure after the removal of the corrugated roof plates, visible is the crawl space which will later serve as the technic room for the rooftop greenhouse

After the removal of the roof covering it was discovered that the wooden structure was still in good shape so the larger beams were repurposed in the supporting structure of the greenhouse platform, saving cost and reducing the environmental impact of the construction itself.

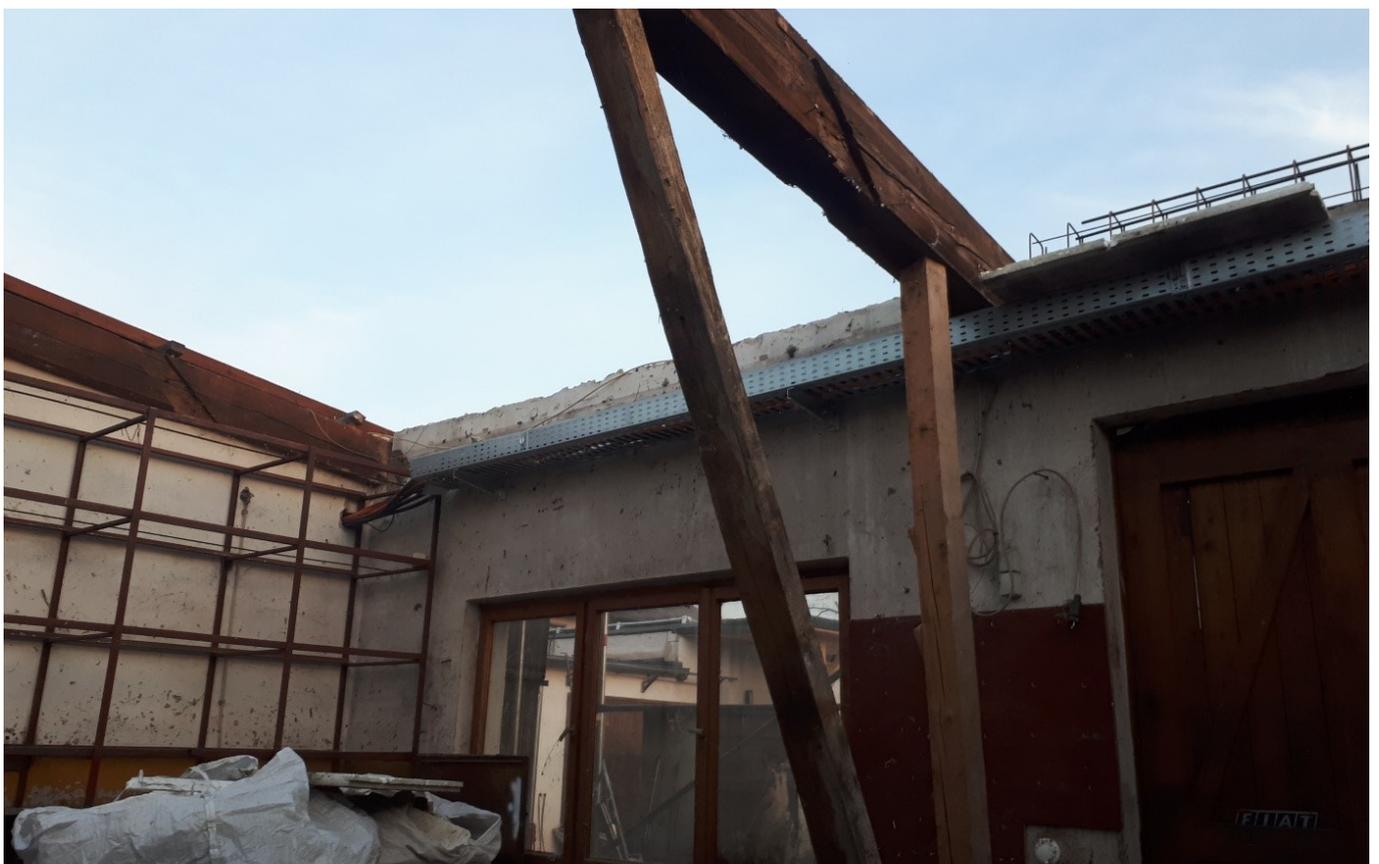
Figure 7 Safety measures for the roof structure before final and safe removal
