**GROOF**  
Greenhouses to Reduce CO<sub>2</sub> on roofS

PART 2 –  
PREPARING THE  
SUPPORT  
BUILDING FOR  
THE ROOFTOP  
GREENHOUSE

**AUTHOR: DAVID VOLK**

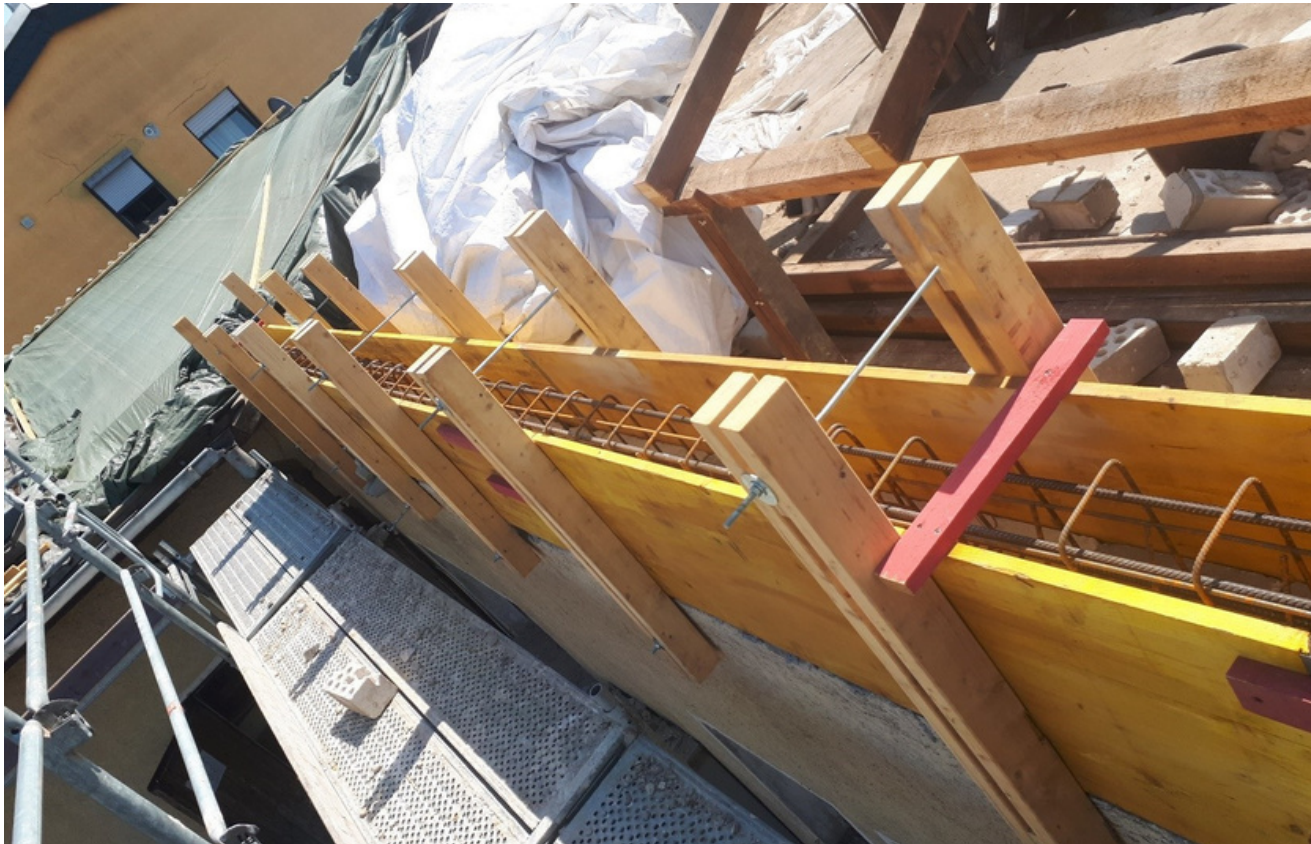
In the previous chapter it was explained how the old roof was removed. After the removal, the walls lay bare and needed to be treated further to give a fitting foundation.

The first problem was we encountered was the old asymmetric saddle roof, resulting in different heights of the walls which needed to be leveled out. The north wall came out nearly 50 cm higher than the south wall. Therefore a concrete ring beam was installed adjusted to the underlying structure.

Structurally, using reinforced concrete was an enormous advantage since we did not have to take any previous openings underneath into account. The reinforced concrete ring beam served therefore not only as a foundation for the greenhouse platform but also as a lintel over the windows and the large gates of the support building. If that would not have been the case, the load of the greenhouse could not have been transferred into the load bearing walls properly.

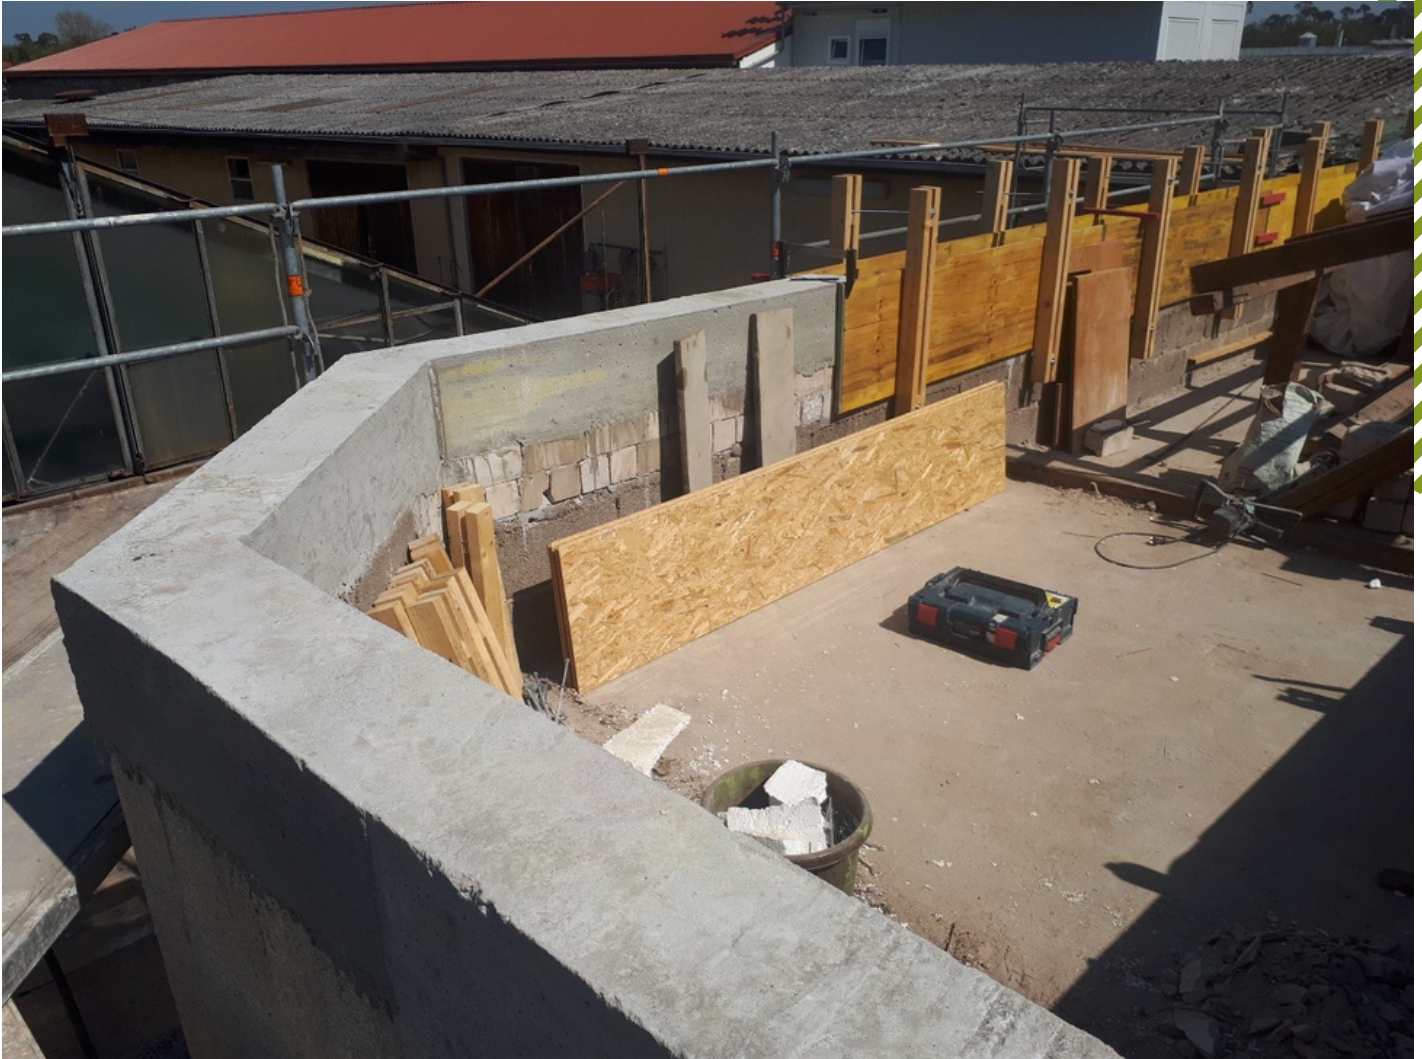
The next step in the construction of the platform involved the placement of the large wooden support beams, which were laid out in a pattern so that the later installed greenhouse post could be placed exactly on top. This reduced the amount of total material necessary since the main load on the platform results from the greenhouse itself and not the growing systems or the live load.

The wooden beams were anchored into the concrete ring beam, despite them moving being unrealistic. The gaps between the beams needed to be filled up otherwise the platform which serves as roof for the support building would have been open to infiltration. The gaps were filled with hempcrete which not only closes the gaps but also serves as a nice insulation method.

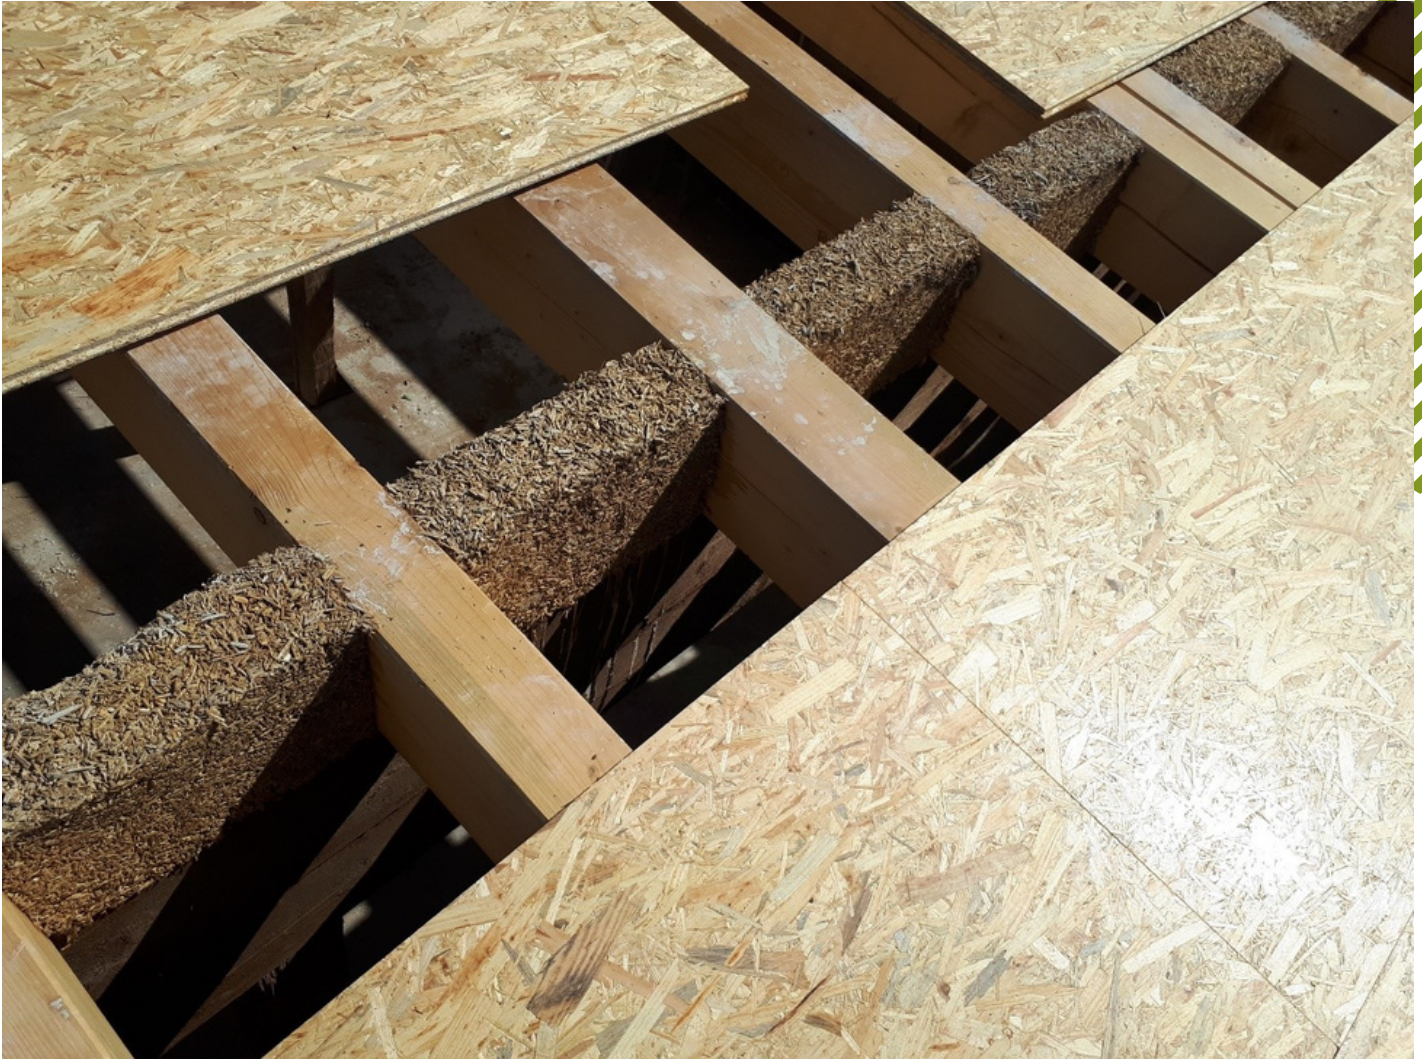
For the platform itself we used standard OSB panels, which are strong enough due to the small gaps they need to traverse and comparatively cheaper than any other solution like multilayer boards. Since the material is not waterproof and is constantly under atmospheric influences, they needed to be sealed off properly. Here, bituminous sheeting was used which was welded in rolls onto the boards.

The construction steps from installing the wooden beams to the OSB boards and finally the roofing felts was done quickly in between rain to prevent any moisture from getting into the substructure of the platform trapping it there creating mould or other damage.

Finally, sheeting metals were installed all around the platform to prevent damage to the edges, finishing the platform itself.
