Refurbishment project of an Alqueria to get almost zero HVAC energy demand

The aim of this project is the refurbishment of a traditional Valencian orchard house, whose constructive typology is called Alqueria, in order to achieve a negligible HVAC energy demand

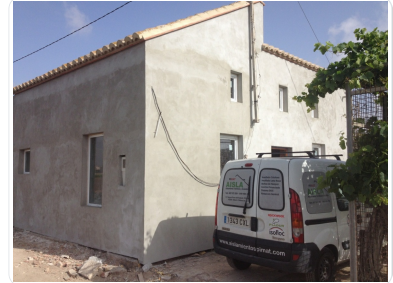
The SATE System: External Thermal Insulation Composite System (ETICS), is an EPS system of thermal and acoustic insulation of facades by the exterior. While other insulation is incorporated to the façade by means of a work, the SATE System is a prefabricated insulation panel that adheres to the façades by means of a mixed fixation (by means of mechanical and adhesive fixing), which gives the façade of an enclosure Thermal insulation that improves energy efficiency and minimizes heat leakage and moisture entry.

This product was very appropriate because it was been easy to install, and it presents a very high resistance to heat transfer.

Therefore, PIMAT Insulation considers that this SATE System is a system of thermal insulation suitable for both new constructions and to rehabilitate deteriorated exterior façades as it provides a greater thermal and acoustic insulation capacity. In addition, it improves the resistance to external agents and hardly needs maintenance.
