Refurbishing with active facade

General information

In this project, an old house became passive or very low energy consumer thanks, above all, to the intervention carried out on the south façade to achieve interior comfort, capturing the heat of the sun and slowly transmitting it to the interior: turning the south façade into an active façade. The original state was a building of uninsulated stone walls, a fairly closed southern facade and of poor structural quality, with small windows and a new but uninsulated roof.

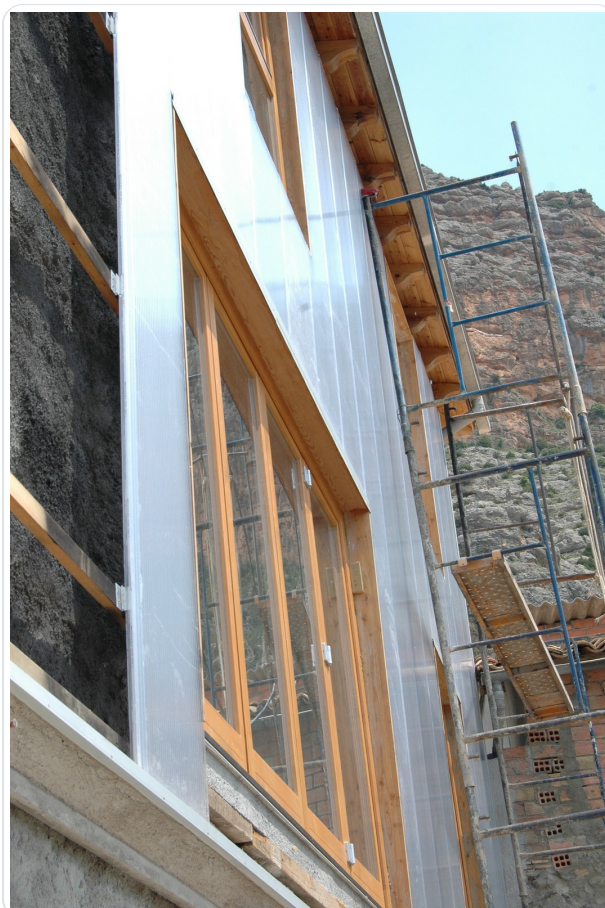
The southern façade is the only surface that has more solar incidence in winter than in summer.

In the northern hemisphere of the planet, winter solar radiation has an angle of incidence quite perpendicular to the wall, but during the summer the sun is much higher and affects less in the vertical plane of the southern façade.

The incidence in summer is much lower and combined with the effect of light reflection on the polycarbonate there is virtually no refracted solar radiation or visible radiation entering the wall in summer: the wall is not heated when the sun is high or summer. On the

other hand, the wall is well heated when the sun is low because there is little reflection and much refraction to the interior of the wall. Luckily this physical phenomenon allows to give the wall much energy in winter and very little in summer. This allows the wall to be used as a heat radiating surface in winter and without damaging it in summer. As will be seen in the graphs of the solar contribution, this contribution of energy is proportional to the demand for heating throughout the year.
