## Accelerating condominium Energy Retrofitting

Roadmap for the sustainable, ambitious  
and efficient renovation of condominiums

## Example: condominium in Liège (1930)

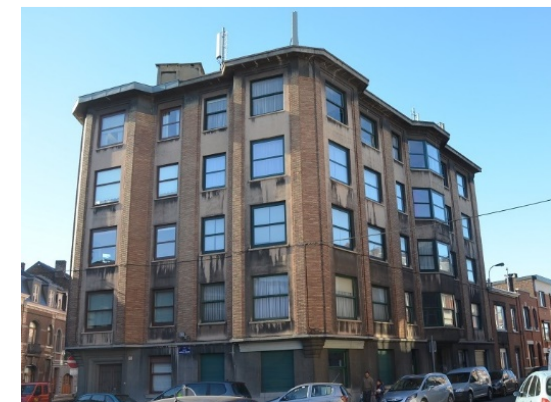
# Diagnosis

- Average  $U_m = 2,26$  W/m²K
- K level: 168
- $E_{spec}$  between 371 and 843 kWh/m².year
- Average = 500 kWh/m².year

- Concrete flat roof, no insulation
  - Recent water damages: pipe leaks
- Solid walls (bricks and other materials), no insulation
- $\pm$  50% of recently changed windows (PVC, insulated + double glazing)
  - Others : simple glazing in old wooden frames, low insulation and not airtight
- Concrete floors on basement, no insulation
- Heating and Domestic Hot Water through recent high temperature fuel boilers
  - Distribution : columns pipes, and DHW loop, uninsulated
- Ventilation : natural exhausts in bathrooms
  - Renewal of interior air by lack of airtightness
- No cooling
- No renewable energy production on site

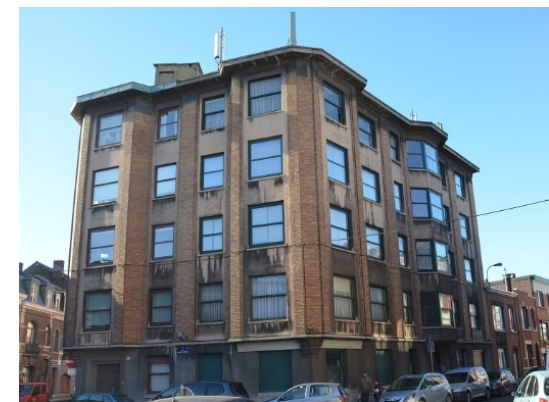
## After phase 1

- Average  $U_m = 1,83$  W/m²K
- K level: 136
- Average  $E_{spec} = 422$  kWh/m².year

- Urgency: roof reparations
  - Coordination with the antennas administrators
  - → thermal insulation and waterproofing
    - Insulation placed in wait for facades works
  - Roof landscaping: garden, vegetable garden, social space
- Renovation and thermal insulation of rooftop volumes
- Remodel of rainwater evacuation networks
  - Rainwater recovery for common uses

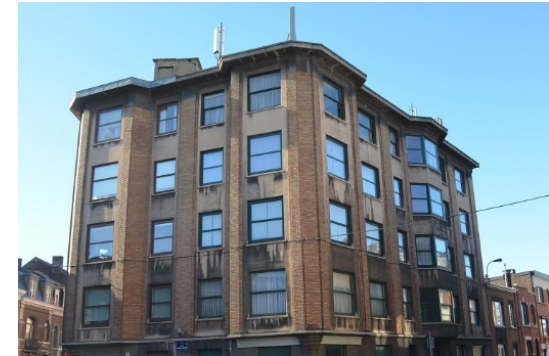
## Coherent phasing of operations : phase 2

- Between 2022 and 2034:
  - Change of windows: “personal” works
  - Thermal insulation of street level: coordination with sidewalks reparations
- In 2034 :
  - Thermal insulation of facades: roughcast on exterior insulation
    - → Technical study for back façade (balconies to insulate)
  - Envelope rendered airtight → installation of mechanical ventilation with heat recovery in each dwelling

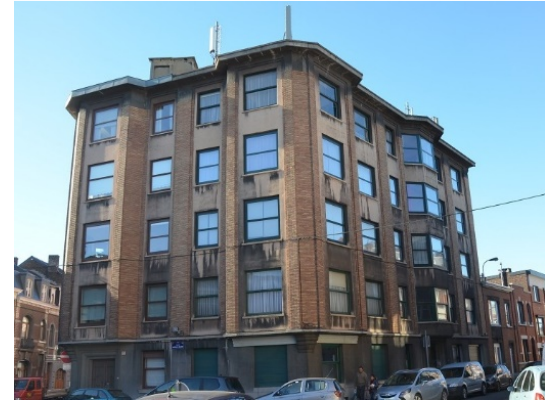
## Coherent phasing of operations : phase 3

- Insulation of floors on basement
- Change of systems
  - Communal boilers for heating
    - Power appropriate for new needs
  - Decentralised systems for DHW
    - Suppression of DHW loop
- Free space on street floor → creation of bicycle shed with electric charge terminal
