Improvement Energy efficiency of the building Multiasistencia

Building Type : Office building < 28m

Construction Year : 1979

General informations

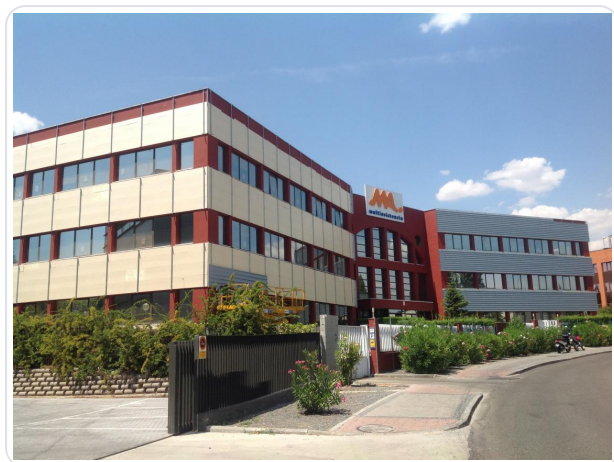
Model "DANOPREN 40"

It is placed with mechanical fixings over the existing enclosure

Union tongued

The ventilated facade gets a great savings in energy consumption, both summer and winter.

The rehabilitation works, for the purpose of improve energy efficiency and thermal conditions, have consisted in putting of a rigid insulation on outer face, as part of the construction of a ventilated facade; which has permitted a significant improvement of the corporate image of the building. For this we have chosen A ventilated facade: improves the insulation has been placed aluminum profiles, which enables the creation of an air chamber. It has also installed a sheet steel: model 'Athena' 'on blind parts, a curtain wall: in the central part of the building on the front facade, and a expanded steel panel: type "Deploye " in the central part of the building in the rear facade.

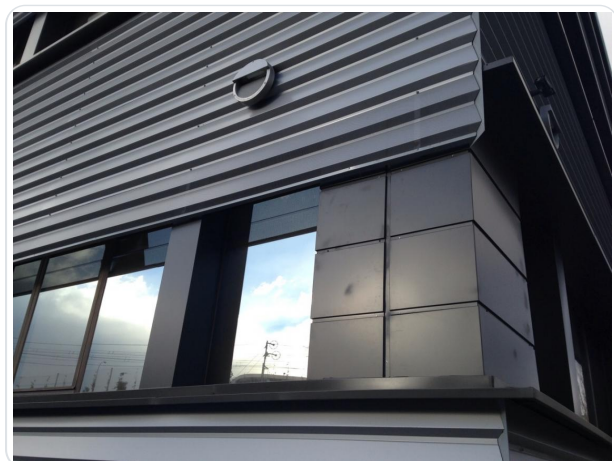
Profiled galvanized steel fixing

Pre-lacquered silver

Although needed mechanical placement, coordinated work of different teams collaborated in

the quick installation, working after hours to prevent workers acoustic discomfort.
