Refurbishing with active facade

by Josep Bunyesc Palacín / 2017-06-01 10:45:18 / España / 9621 / ES

Building Type : Isolated or semi-detached house

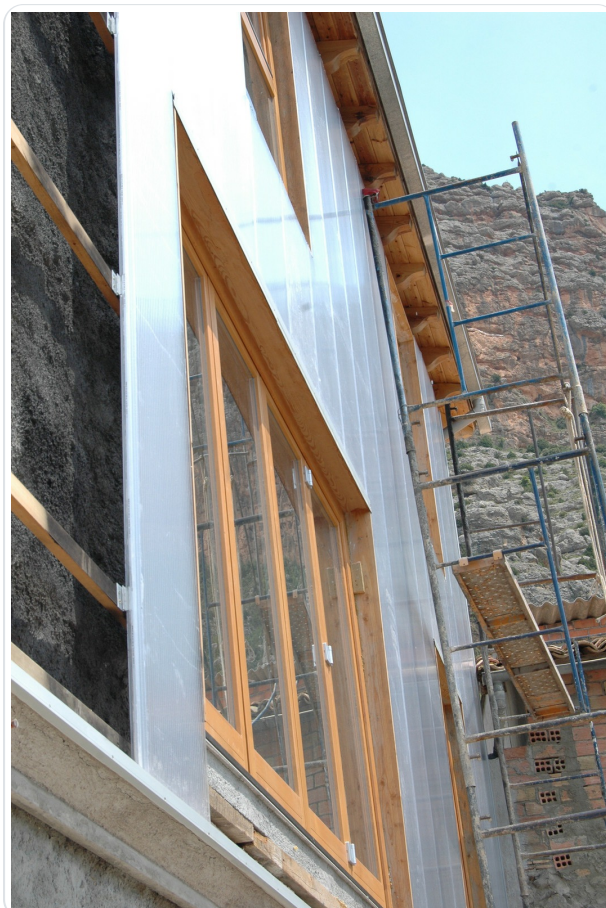
The incidence in summer is much lower and combined with the effect of light reflection on the polycarbonate there is virtually no refracted solar radiation or visible radiation entering the wall in summer: the wall is not heated when the sun is high or summer. On the

other hand, the wall is well heated when the sun is low because there is little reflection and much refraction to the interior of the wall. Luckily this physical phenomenon allows to give the wall much energy in winter and very little in summer. This allows the wall to be used as a heat radiating surface in winter and without damaging it in summer. As will be seen in the graphs of the solar contribution, this contribution of energy is proportional to the demand for heating throughout the year.

The southern façade is the only surface that has more solar incidence in winter than in summer.

In the northern hemisphere of the planet, winter solar radiation has an angle of incidence quite perpendicular to the wall, but during the summer the sun is much higher and affects less in the vertical plane of the southern façade.
