## CasaClima Class A - House B in Sacile

**Building Type** : Terraced Individual housing  
**Construction Year** : 2022  
**Delivery year** : 2022  
**Address 1 - street** : via dello sport 33077 SACILE, Italia  
**Climate zone** : [Csa] Interior Mediterranean - Mild with dry, hot summer.

**Net Floor Area** : 154 m² Other  
**Construction/refurbishment cost** : 250 000 €  
**Cost/m²** : 1623.38 €/m²

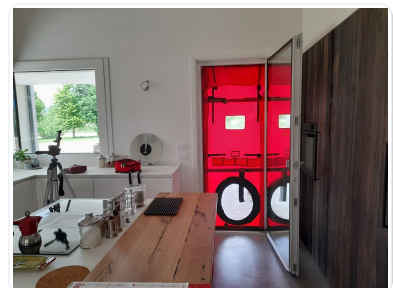
Unique method for the realization of Blower door Test to collaborate to achieve successes and not to certify defeats.

The method provides for the continuous updating of all the craftsmen throughout the manufacturing process
