Refurbishing with active facade

by Josep Bunyesc Palacín / 2017-06-01 10:45:18 / España / 9824 / ES

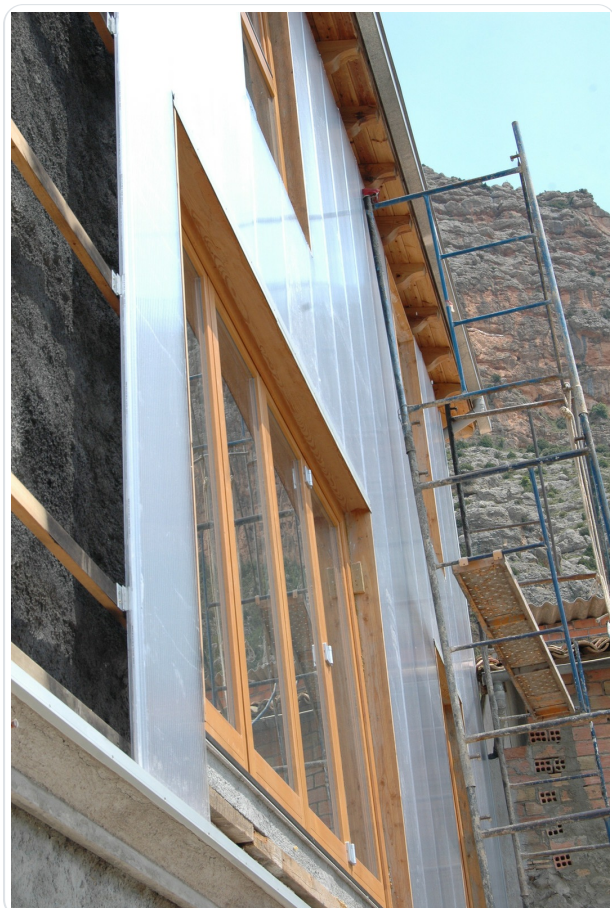
The incidence in summer is much lower and combined with the effect of light reflection on the polycarbonate there is virtually no refracted solar radiation or visible radiation entering the wall in summer: the wall is not heated when the sun is high or summer. On the

other hand, the wall is well heated when the sun is low because there is little reflection and much refraction to the interior of the wall. Luckily this physical phenomenon allows to give the wall much energy in winter and very little in summer. This allows the wall to be used as a heat radiating surface in winter and without damaging it in summer. As will be seen in the graphs of the solar contribution, this contribution of energy is proportional to the demand for heating throughout the year.

The southern façade is the only surface that has more solar incidence in winter than in summer.

In the northern hemisphere of the planet, winter solar radiation has an angle of incidence quite perpendicular to the wall, but during the summer the sun is much higher and affects less in the vertical plane of the southern façade.
