Improvement Energy efficiency of the building Multiasistencia

Building Type : Office building < 28m

Construction Year : 1979

The Multiasistencia headquarters is located at Tres Cantos town, it was built in 1979. It is located between the Ronda de Poniente, the railway and two other office buildings on both sides. The plot has 4541 m² of surface, with a floor area of 1446 m², the total constructed area is 5903 m².

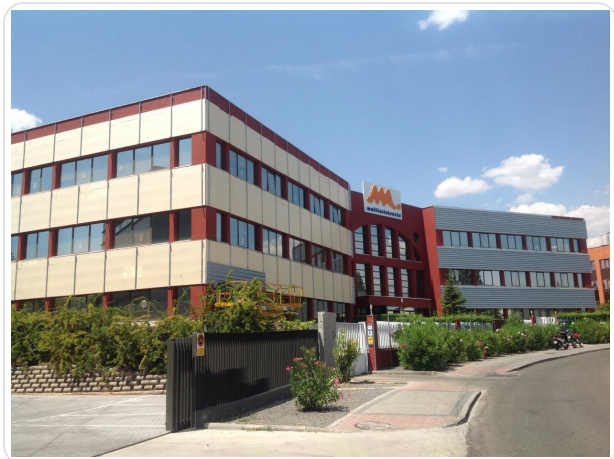
Model "DANOPREN 40"

It is placed with mechanical fixings over the existing enclosure

Union tongued

The ventilated facade gets a great savings in energy consumption, both summer and winter.

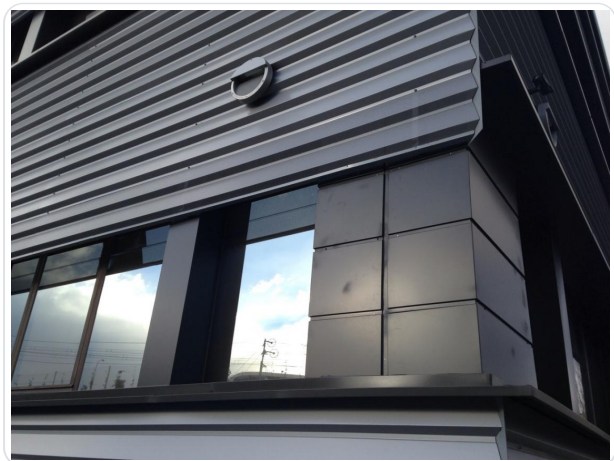
ARCHITECTURAL METAL PROFILE

Profiled galvanized steel fixing

Pre-lacquered silver

Although needed mechanical placement, coordinated work of different teams collaborated in

the quick installation, working after hours to prevent workers acoustic discomfort.

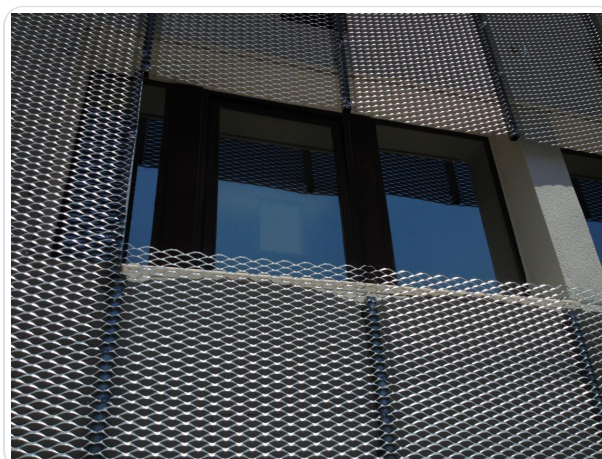
The rear facade has been met with a panel of expanded steel, type "deploye".

Expanded metal mesh type RO90 (90x30x9), starting for manufacturing materials galvanized steel GA 275 DX 51D + Z NAC 1.5 mm thick.

Perforated plate was used on top of the windows, reducing by 30% the incidence of the sun setting over the holes.

The rehabilitation works, for the purpose of improve energy efficiency and thermal conditions, have consisted in putting of a rigid insulation on outer face, as part of the construction of a ventilated facade; which has permitted a significant improvement of the corporate image of the building. For this we have chosen A ventilated facade: improves the insulation has been placed aluminum profiles, which enables the creation of an air chamber. It has also installed a sheet steel: model 'Athena' 'on blind parts, a curtain wall: in the central part of the building on the front facade, and a expanded steel panel: type "Deploye " in the central part of the building in the rear facade.

They have installed new vents and air exchange exterior-interior, its aesthetically integrated under the sheets "deploye" the core of the rear facade, help to improve environmental conditions inside the offices; while the replacement of all control systems the installations, get a reduction and greater user comfort.
