Improvement Energy efficiency of the building Multiasistencia

Building Type : Office building < 28m

Construction Year : 1979

The rehabilitation works, for the purpose of improve energy efficiency and thermal conditions, have consisted in putting of a rigid insulation on outer face, as part of the construction of a ventilated facade; which has permitted a significant improvement of the corporate image of the building. On the other hand, the air conditioning system has improved, replacing the current machines, with more efficient ones; enhancements have also been made in the ventilation system.

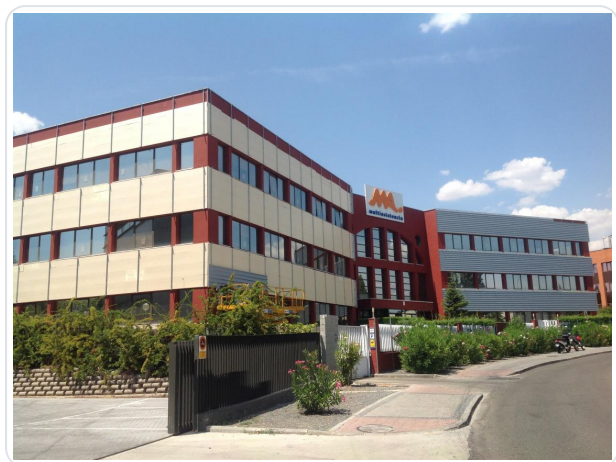
Model "DANOPREN 40"

It is placed with mechanical fixings over the existing enclosure

Union tongued

The ventilated facade gets a great savings in energy consumption, both summer and winter.

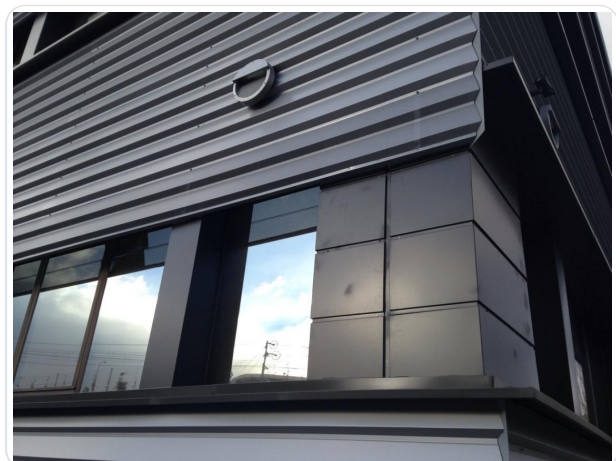
ARCHITECTURAL METAL PROFILE

Profiled galvanized steel fixing

Pre-lacquered silver

Although needed mechanical placement, coordinated work of different teams collaborated in the quick installation, working after hours to prevent workers acoustic discomfort.

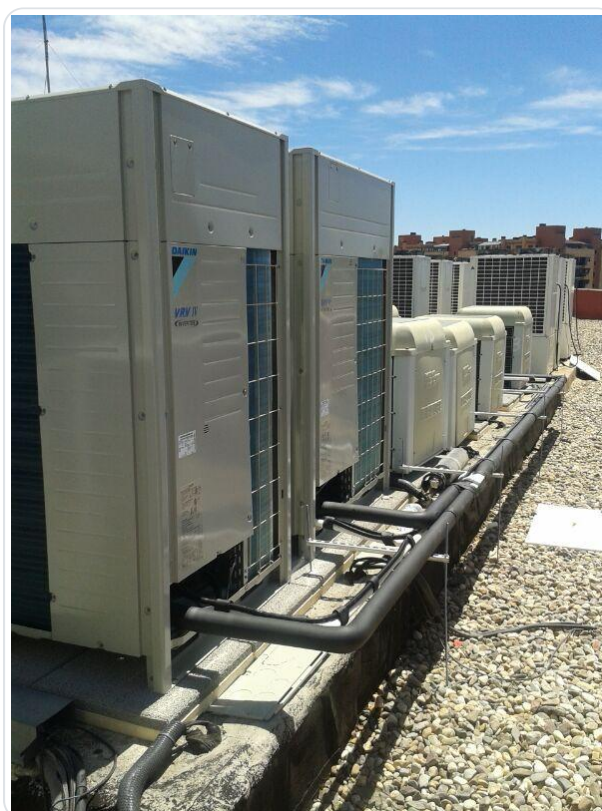
AIR ACONDITINING

The Daikin VRV system is a multi-split type air conditioner that uses variable refrigerant flow control developed by Daikin to provide customers with the ability to maintain individual zone control in each room and floor of a building.

Indoor unit: model FXSQ20P

This system managed to reach comfort temperatures faster.

The air conditioning system has been divided into eight sub-systems.

It has been considered fundamental change of heat-generating equipment cold to a VRV model, with the aim of improve system efficiency and adapt to current legislation gases such machinery used. For the purpose of improve energy efficiency and thermal conditions it has been chosen by an outer insulation of facades fixed to the wall. It has improved system performance ventilation and air conditioning system replacing existing machines by other more.
