Refurbishing with active facade

Building Type : Isolated or semi-detached house

Construction Year : 2014

Address 1 - street : 25518 PESSONADA, CONCA DE DALT, España

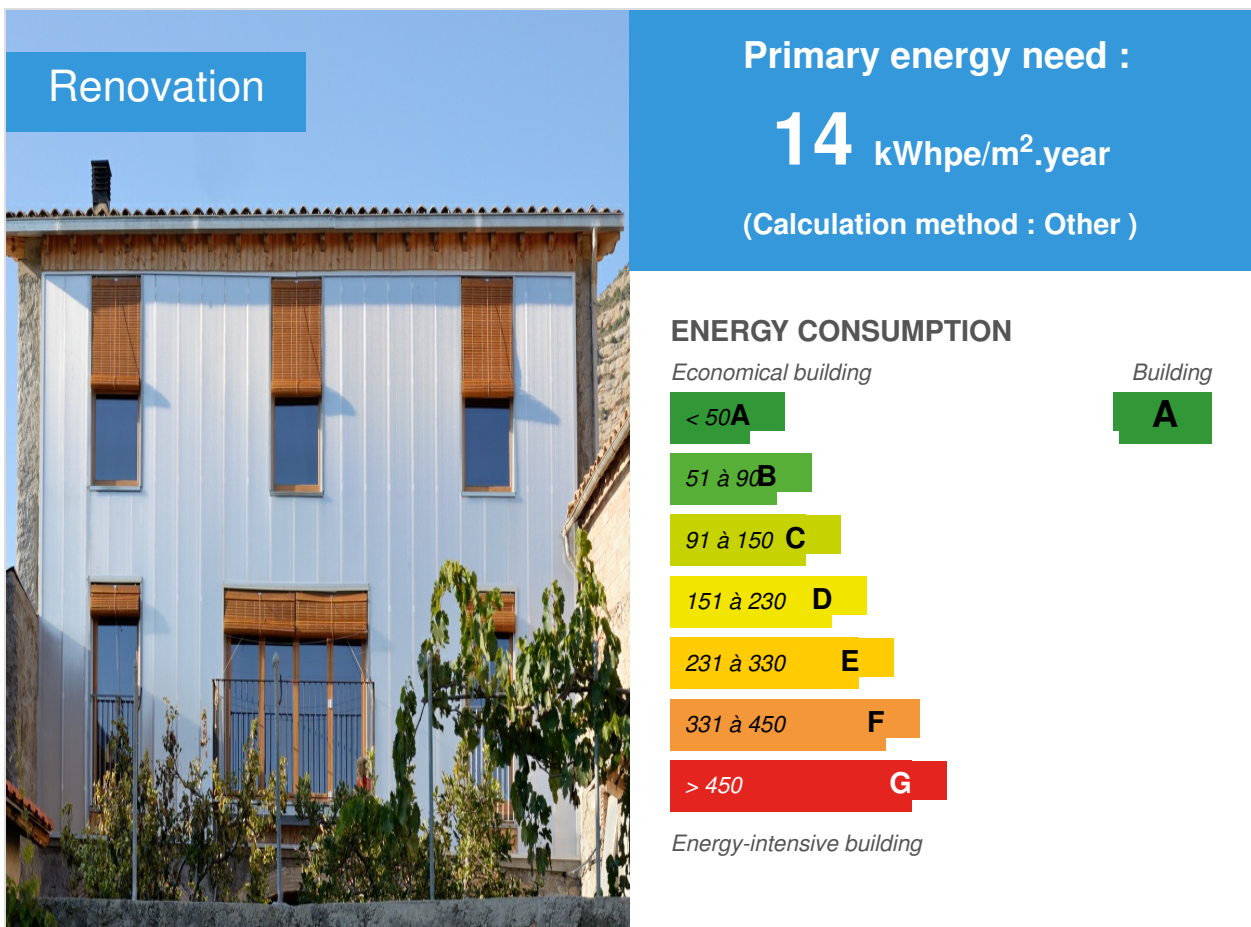
In this project, an old house became passive or very low energy consumer thanks, above all, to the intervention carried out on the south façade to achieve interior comfort, capturing the heat of the sun and slowly transmitting it to the interior: turning the south façade into an active façade. The original state was a building of uninsulated stone walls, a fairly closed southern facade and of poor structural quality, with small windows and a new but uninsulated roof.

In this project, an old house became passive or very low energy consumer thanks, above all, to the intervention carried out on the south façade to achieve interior comfort, capturing the heat of the sun and slowly transmitting it to the interior. The original state was a building of uninsulated stone walls, a fairly closed southern facade and of poor structural quality, with small windows and a new but uninsulated roof. Due to the poor state of the southern façade, windows could not be made much larger than the existing ones. It was difficult to capture solar energy passively inland. In order to capture energy through the opaque part of the façade, 8-ply polycarbonate panels were installed on the exterior, which made the southern facade a large passive solar collector and, consequently, its old stone wall turned into an accumulator wall and passive radiator in the interior of low temperature and of great surface. The rest of the walls and cover were insulated by the interior.
