Improvement Energy efficiency of the building Multiasistencia

Building Type : Office building < 28m

The Multiasistencia headquarters is located at Tres Cantos town, it was built in 1979. It is located between the Ronda de Poniente, the railway and two other office buildings on both sides. The plot has 4541m² of surface, with a floor area of 1446m², the total constructed area is 5903 m².

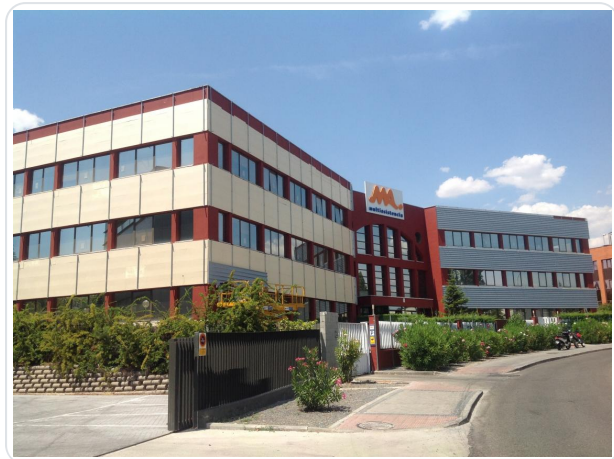
Model "DANOPREN 40"

It is placed with mechanical fixings over the existing enclosure

Union tongued

The ventilated facade gets a great savings in energy consumption, both summer and winter.

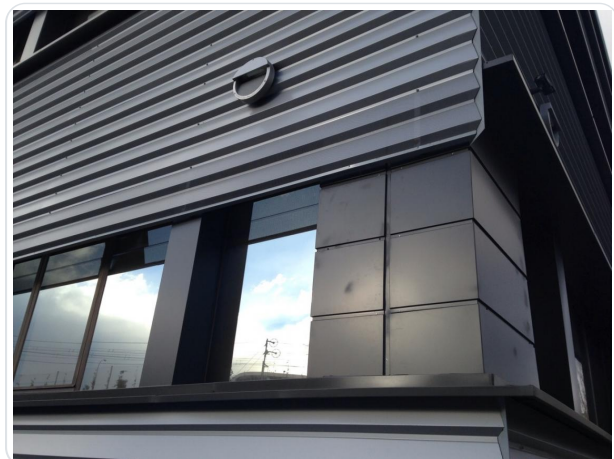
ARCHITECTURAL METAL PROFILE

Profiled galvanized steel fixing

Pre-lacquered silver

Although needed mechanical placement, coordinated work of different teams collaborated in

the quick installation, working after hours to prevent workers acoustic discomfort.
