## Improvement Energy efficiency of the building Multiasistencia

**Building Type** : Office building < 28m

**Construction Year** : 1979

The Multiasistencia headquarters is located at Tres Cantos town, it was built in 1979. It is located between the Ronda de Poniente, the railway and two other office buildings on both sides. The plot has 4541m<sup>2</sup> of surface, with a floor area of 1446m<sup>2</sup>, the total constructed area is 5903 m<sup>2</sup>.

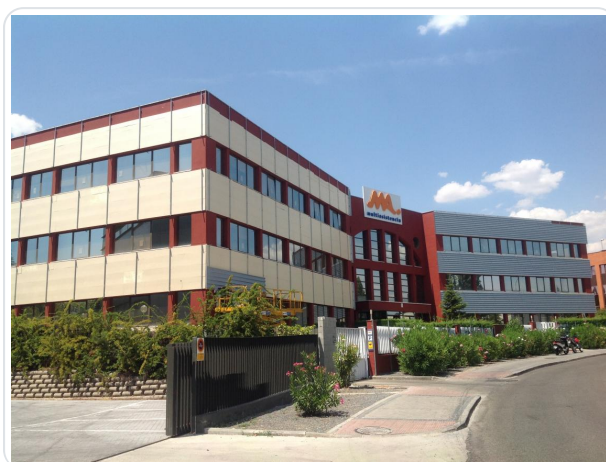
Model "DANOPREN 40"

It is placed with mechanical fixings over the existing enclosure

Union tongued

The ventilated facade gets a great savings in energy consumption, both summer and winter.

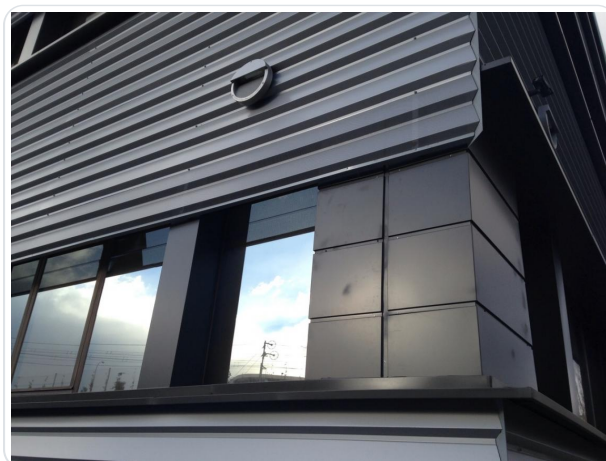
#### ARCHITECTURAL METAL PROFILE

Profiled galvanized steel fixing

Pre-lacquered silver

Although needed mechanical placement, coordinated work of different teams collaborated in

the quick installation, working after hours to prevent workers acoustic discomfort.

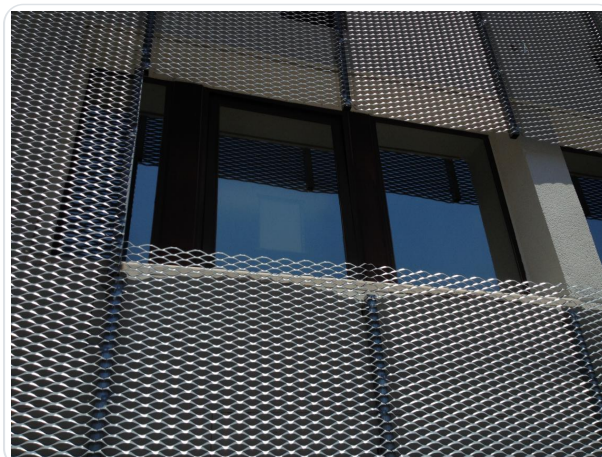
The rear facade has been met with a panel of expanded steel, type "deploye".

Expanded metal mesh type RO90 (90x30x9), starting for manufacturing materials galvanized steel GA 275 DX 51D + Z NAC 1.5 mm thick.

Perforated plate was used on top of the windows, reducing by 30% the incidence of the sun setting over the holes.

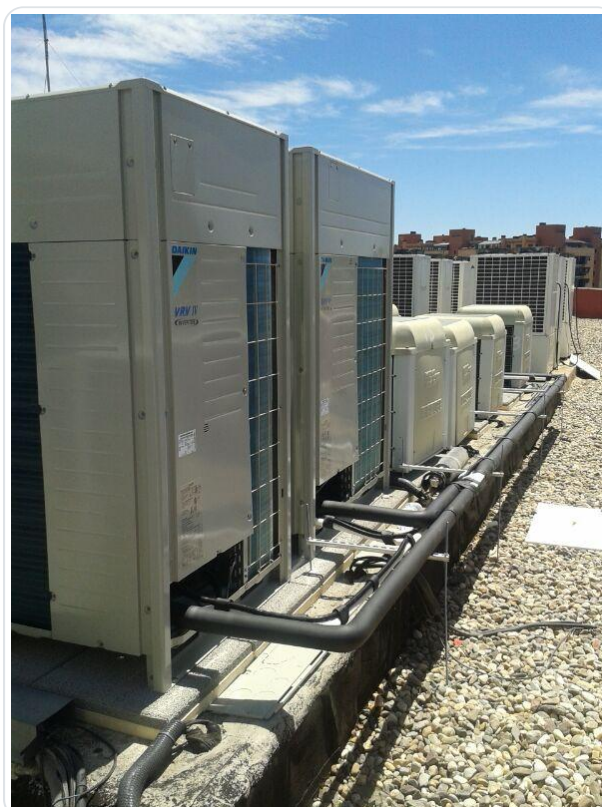
The Daikin VRV system is a multi-split type air conditioner that uses variable refrigerant flow control developed by Daikin to provide customers with the ability to maintain individual zone control in each room and floor of a building.

Indoor unit: model FXSQ20P

This system managed to reach comfort temperatures faster.

It has been considered fundamental change of heat-generating equipment cold to a VRV model, with the aim of improve system efficiency and adapt to current legislation gases such machinery used. For the purpose of improve energy efficiency and thermal conditions it has been chosen by an outer insulation of facades fixed to the wall. It has improved system performance ventilation and air conditioning system replacing existing machines by other more.
