# **Niama**

**Building Type**: Collective housing < 50m

Address 1 - street: Ravine Blanche 97410 SAINT PIERRE, LA RéUNION, France

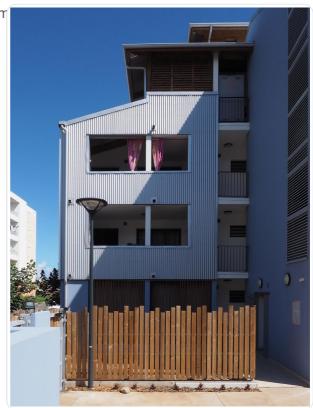
Chance Brizz

ArcelorMittal

Product category: Structural work / Carpentry, cover, titghtness

The roof is composed of an insulated sheet m and 13mm of plasterboard.
