Health House Billé

Building Type : Public or private hospital
Construction Year : 2013
Delivery year : 2015
Address 1 - street : 5 rue de Fougères 35133 BILLÉ, France
Climate zone : [Cfb] Marine Mild Winter, warm summer, no dry season.

Proposed by :
BATYLAB

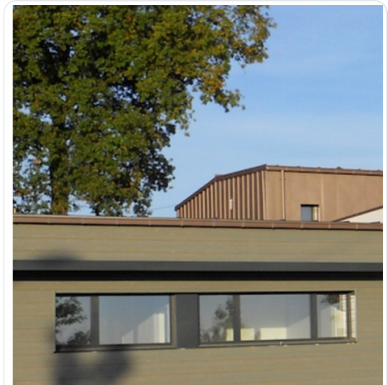
In the programming, it is mentioned that the project manager will endeavor to use materials that are healthy and have little impact on the environment. Several responses in the choice of materials reflect this desire as the choice of a constructive mode integrating wooden framework. Another example is the protection of wood structures (frameworks) against underground termites (in accordance with the provisions of the decree of 27 June 2006 on the application of Articles R112-2 and R112-3 of the Construction Code and Of the Habitation) it was prohibited the use of chemicals and insecticides. A physical barrier has been prescribed.
