Headquarters of the Order of Architects Réunion / Mayotte

Building Type : Office building < 28m

The project involves renovating and raising a "concrete hut" typical of 21st century Reunionese architecture.

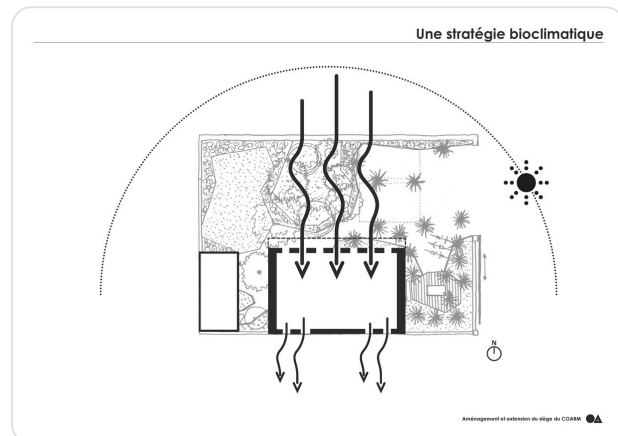
Passive cooling solution: natural ventilation

The project works passively: in fact, no installation or system is planned to provide thermal comfort to users.

The design is based on the foundations of tropical bioclimatic architecture: through natural ventilation and solar protection.

The existing house is therefore renovated in this sense: partitions are removed in

favor of trellises in order to promote natural ventilation, the shutters are rehabilitated for solar protection, air blowers are put in place to ensure cooling throughout. of the year.

The elevation was designed to meet these two objectives: the reused joinery was redesigned to allow an opening favoring natural ventilation. A compass system allowing easy and constant opening during use.

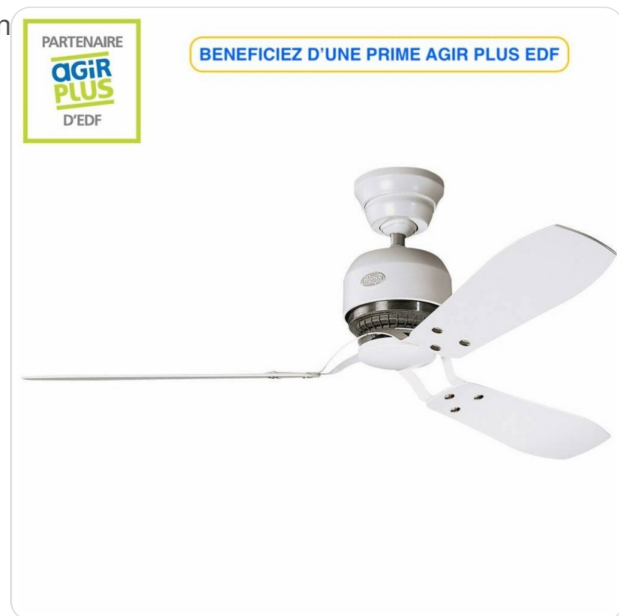
Air blower

The climatic context of Reunion and a response to ensure fluctuations of incoming and outgoing air (open permeability) which will solve the problems of air quality and evacuation of internal thermal loads. On the other hand, for certain windy geographical areas or for certain periods of the year when the wind is weak, the ventilation strategy developing natural dynamic irrigation currents will need to be assisted. We will then use the ceiling fan.

This solution is implemented on the Order's Headquarters project with one ceiling fan per office or work area/small meeting.

The Council Chamber will have 4 ceiling fans to ensure real comfort for all occupants.
